Way back in June 2009, in the VCA Crane Safety Bulletin number eight, we discussed a topic that was referred to as Tyre Pyrolysis. When a machine has suffered from a contact with an electrical source, there is potential for that energy to be released through the rubber tyres that are fitted to it. This energy may have come from high voltage contact incidents such as contact with overhead supply lines, or as these pictures show, it can also be caused from lightning.

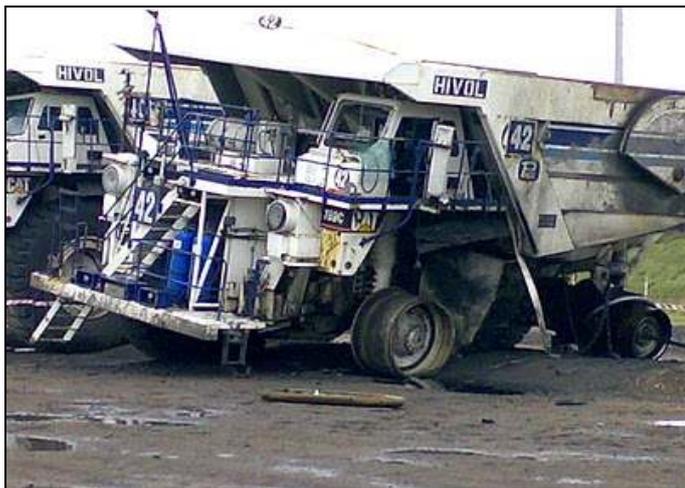
The machine pictured above is a Cat 789C and the tyres were said to have blown off the truck minutes after the lightning strike. One wheel assembly weighing 1.6t was thrown about 100m from the machine, and other components found up to 275m away as seen in the image below. The truck also suffered extensive damage including major driveline damage and the door & glass blown open.

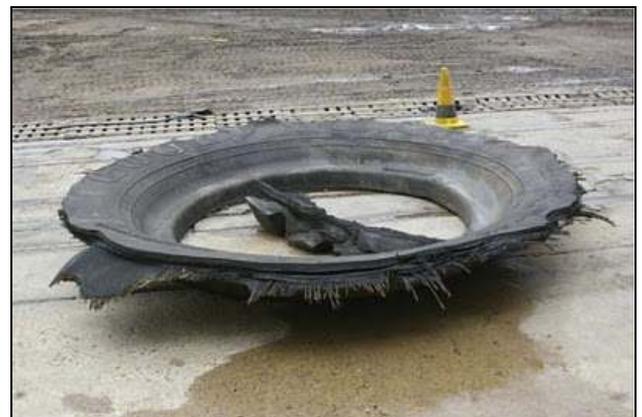
These dump trucks weigh 130t unloaded, and have a loaded weight of 320t, so they are somewhat bigger than any of the cranes that travel on our roads. They carry a larger tyre sizes as well. Yet the potential for a similar event is possible. When the size of one of the tyre sections that blew off is shown up close below, it's easy to appreciate that that a greater understanding of this phenomenon is something that all of us in the crane and related industries should be aware of.
