**Greetings all. Today's topic is about Tyre fires, pyrolysis and explosions.**

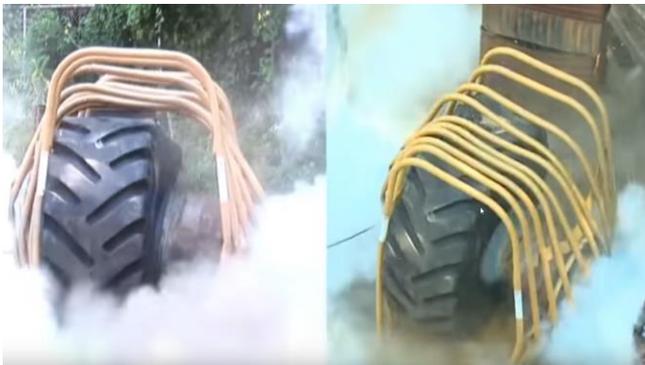
The tyres above are undergoing a controlled test and have exploded and destroyed the steel safety cage around them. Note that these tyres are half the size of a crane tyre. The tyre below is only a truck tyre, but it's clear that the test dummy won't be used again.
