RESPA Case Study

Title: Hitachi Mining Shovels EX3600 in Open Pit Coal Mine

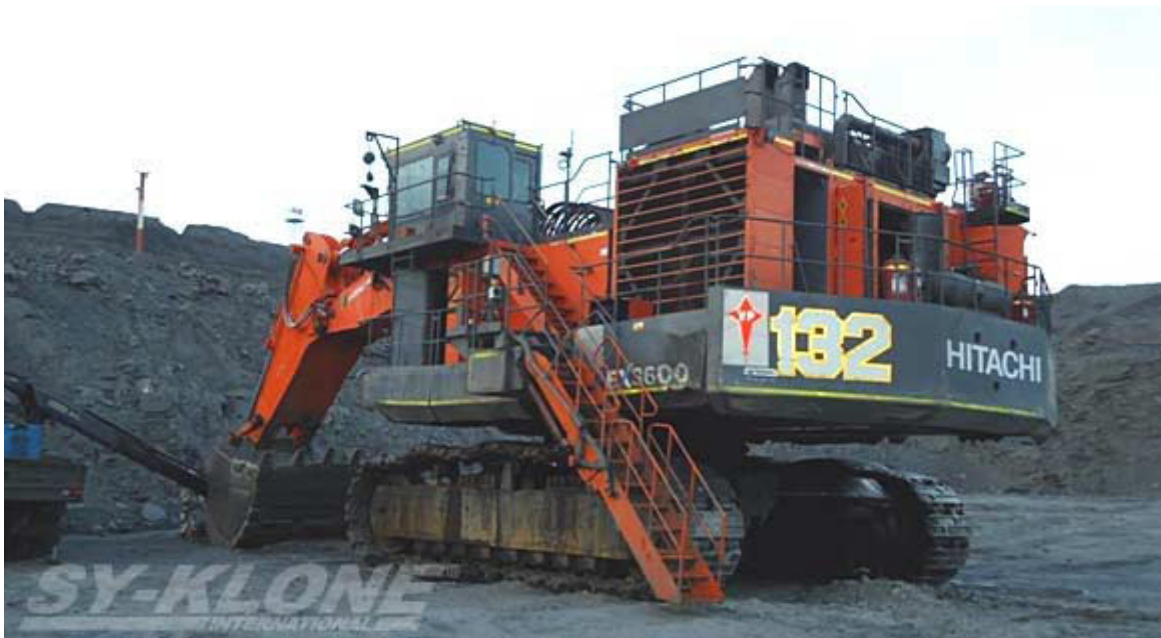
Test machine is one of five EX3600's equipped with the RESPA-CF Vortex HyperFLOW Cab Air Quality System operating in the coal mine. As of the date of this report all five machines have exceeded 1000 hours of run time with similar results!

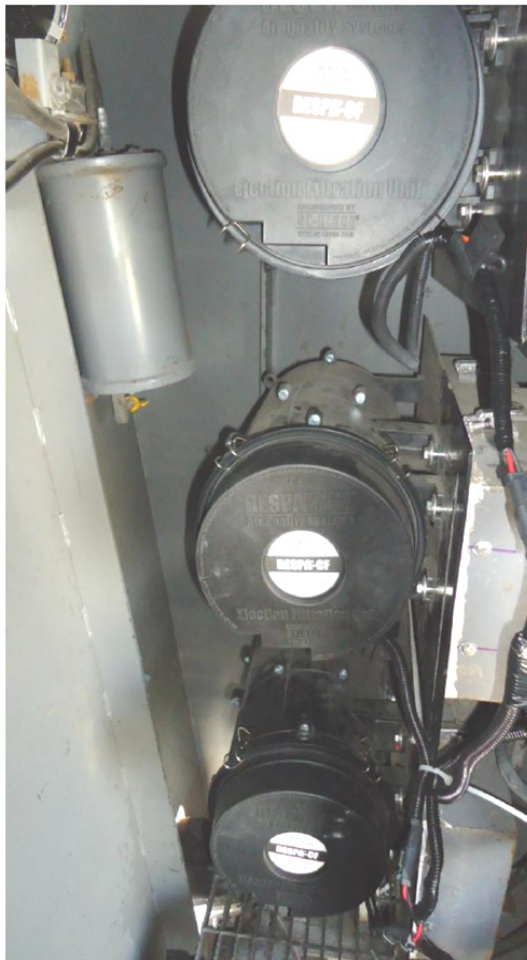
Fresh Air Intake Three RESPA-CF Units

Total Hours Spent on Installation:	7
Machine Hours:	28851
A/C Serviced:	yes
Initial Cabin Pressure:	1.15" W.G. (285 Pascal)
Cabin Sealing Required:	no
Cabin Pressure After Sealing:	
Installation Location:	<input type="checkbox"/> Roof <input type="checkbox"/> Hood
	<input type="checkbox"/> Side of Cab
Notes:	Installation made with kit REV3k9 under the cab, using 3 RESPA-CF fresh air systems and 3 RESPA-FFX non-powered recirculation systems.

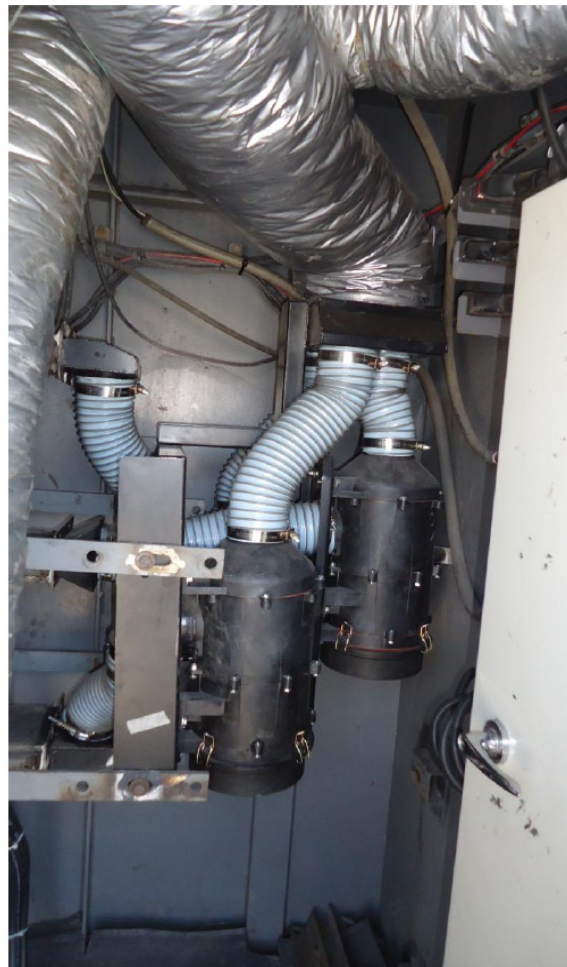
Recirculation Air Three RESPA-FFX Units
