Way back in June 2009, in the VCA Crane Safety Bulletin number eight, we discussed a topic that was referred to as Tyre Pyrolysis. When a machine has suffered from a contact with an electrical source, there is potential for that energy to be released through the rubber tyres that are fitted to it. This energy may have come from high voltage contact incidents such as contact with overhead supply lines, or as these pictures show, it can also be caused from lightning.

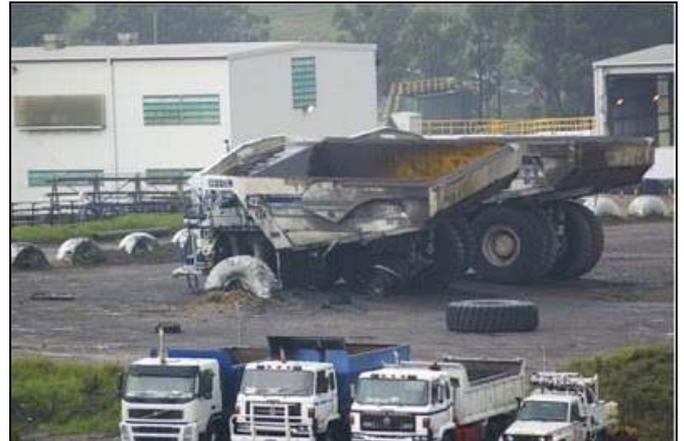
The machine pictured above is a Cat 789C and the tyres were said to have blown off the truck minutes after the lightning strike. One wheel assembly weighing 1.6t was thrown about 100m from the machine, and other components found up to 275m away as seen in the image below. The truck also suffered extensive damage including major driveline damage and the door & glass blown open.

These dump trucks weigh 130t unloaded, and have a loaded weight of 320t, so they are somewhat bigger than any of the cranes that travel on our roads. They carry a larger tyre sizes as well. Yet the potential for a similar event is possible. When the size of one of the tyre sections that blew off is shown up close below, it's easy to appreciate that that a greater understanding of this phenomenon is something that all of us in the crane and related industries should be aware of.

Information on Tyre Pyrolysis that was distributed by the Qld Department of Mines in 2004 can be found here http://mines.industry.qld.gov.au/assets/inspectorate/safety_bulletin047.pdf, but in summary, the following points were made. **In the event of a rubber tyred vehicle making contact with overhead powerlines, the vehicle should be parked in an isolation area with a minimum 300m radius, all personnel should be removed from the area and fire fighting services should be notified.**
