RESPA™ Trial 2009

Occupational hygiene monitoring for airborne particulate matter and respirable crystalline silica inside of an excavator cabin - before and after fitting a pre-cleaner, filter and pressurisation unit.

File 042066

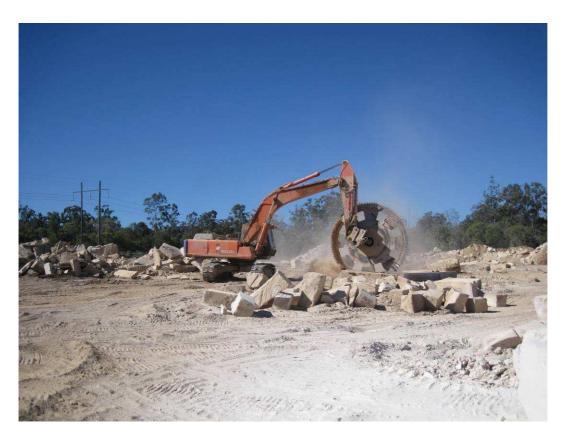
Photograph # 1; Airborne dust being generated from 350 LCH excavator saw attachment cutting sandstone.

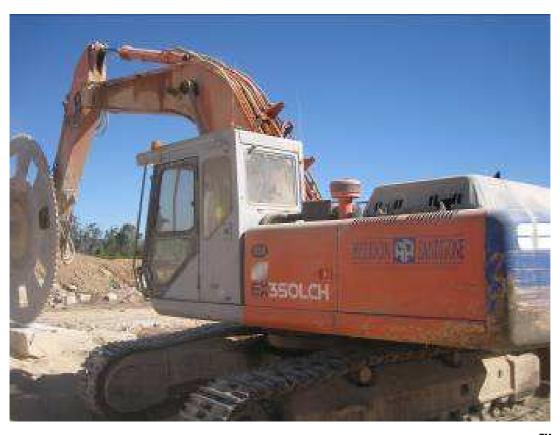
Photograph # 2; 350 LCH excavator, with saw attachment, cutting sandstone with RESPA[™] SD unit installed (mounted behind cabin).

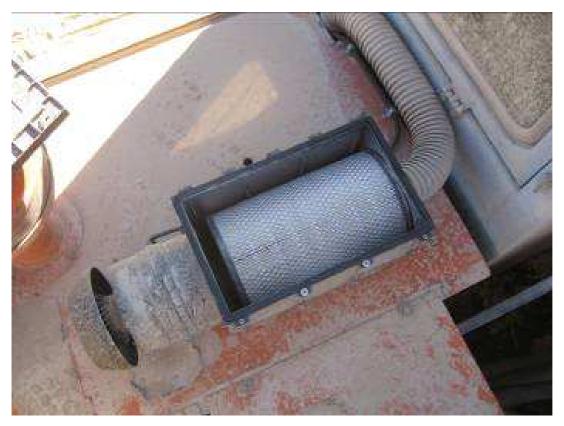
Photograph # 3; 350 LCH excavator, showing close-up of RESPA SD^{TM} (external air supply) unit showing un-housed filter.

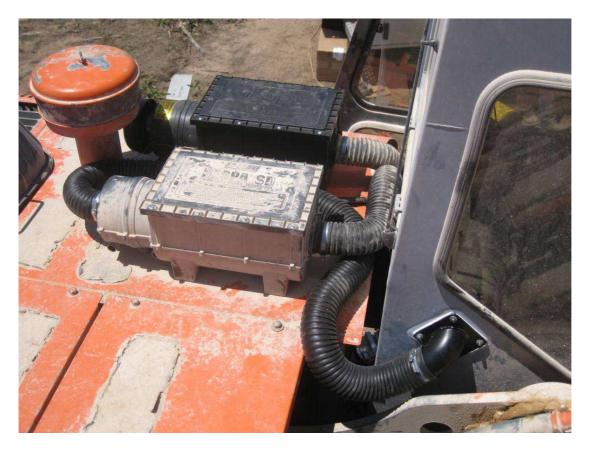
Photograph # 4; 350 LCH excavator, showing close-up of RESPA SD[™] (external air supply) + RESPA SD[™] (recirculated air) units showing housed filter.

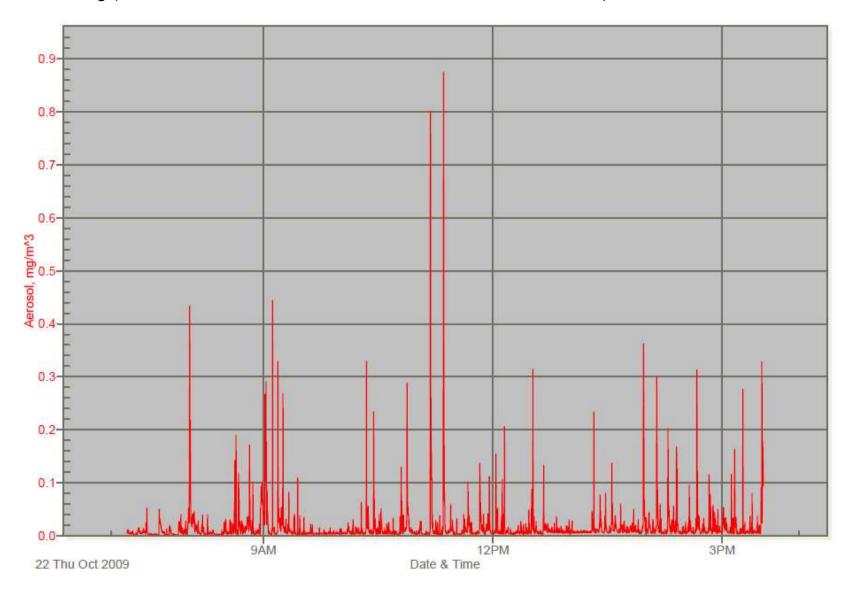
Trenching (RESPA™ for external air and RESPA™ for recirculated air)

Appendix IV Graphs for real time air monitoring by AM510™ with cyclone attachment, measuring respirable dust, without RESPA™ (28 July 2009), with single RESPA™ (20 October 2009) and with second unit for recirculated air (22 October 2009) during trenching.

Appendix IV Graphs for real time air monitoring by AM510[™] with cyclone attachment, measuring respirable dust, without RESPA[™] (28 July 2009), with single RESPA[™] (20 October 2009) and with second unit for recirculated air (22 October 2009) during trenching.

Graphs from real time monitoring in *appendices ii and iv* show a graphical representation in the reduction in both PM1 using TSI DRX[™] and respirable dust using an AM510[™] with cyclone attachment respectively.

Preliminary results to date haven't demonstrated any additional reduction from installing a second unit to filter re-circulated air, however this monitoring was only conducted over a single shift. During this shift the operator was estimated to have exited the cabin on up to sixty (60) occasions. These are not typical of the conditions experienced during other stages of the trial. To determine the effectiveness and benefits of installing a second RESPA unit in this application further monitoring needs to be conducted.
